UPDATED INTERNACHI RESIDENTIAL -2026-04-07

123 Sample Street, Demo City, ST 12345

6/04/2026 8:52AM

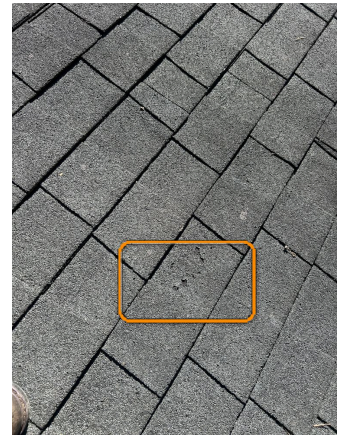
### 2.2.3 Damaged (General)

Roof coverings showed moderate damage. Recommend a qualified roofing professional evaluate and repair.

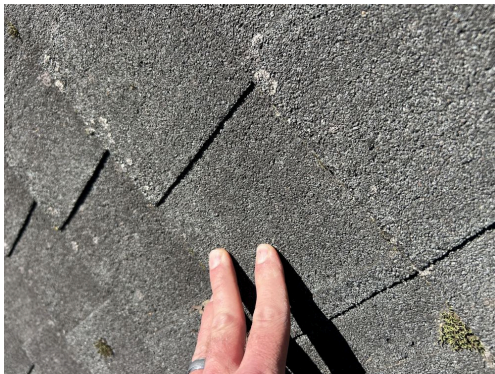
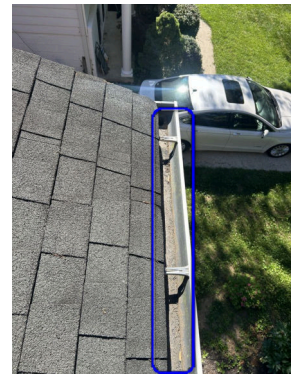
### 2.2.4 Granule Loss - Minor

Slight granule loss was noted on the roof covering, and visible in the gutters of the property. Granule loss that is uniform across the roof is usually a result of normal weathering. Over time, the bond between the granules and asphalt deteriorates, and granules will be loosened and carried away by runoff. Newly installed roofs can also shed a large amount of granules called "hitchhikers." These are granules that were on top of the shingles during manufacturing, but were not completely embedded, and wash away easily during precipitation. Recommend monitoring the area for any signs of further granule loss or erosion of the shingles.

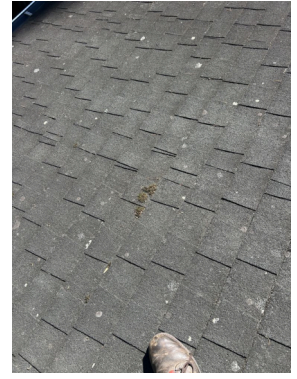
### 2.2.5 Moss growing on shingles

There is moss growing in one or more areas of the roof. Moss grows on a roof when there is adequate moisture and debris to promote growth. Because moss growing on a roof surface will hold moisture on the roof longer than other areas, these growths can reduce the life of the roof covering. Recommend cleaning moss off the roof - We recommend NOT using a power washer to clean the roof as it can damage the shingles.

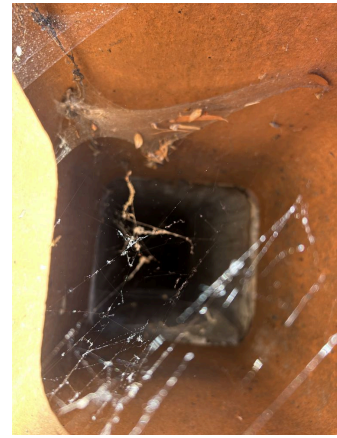
The chimney was unlined, which can deteriorate the chimney structure and allow harmful gasses to enter home. Recommend a qualified masonry or chimney contractor evaluate and remedy.

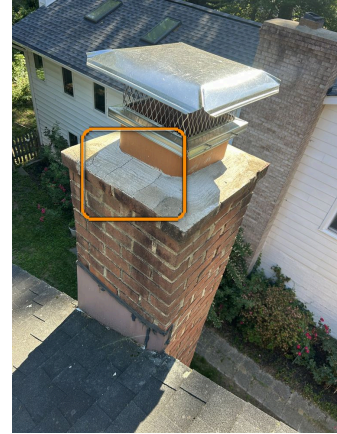
### 2.5.3 Chimney Crown Cracked

The mortar securing the chimney crown is deteriorating. This can lead to further damage of the chimney, and loose or falling bricks. Recommend repair by a qualified chimney professional or mason.

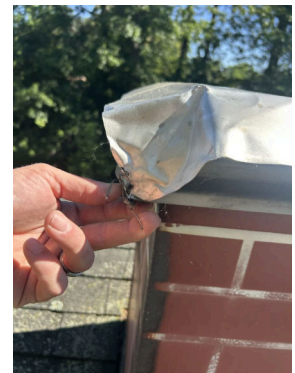
### 2.5.4 Chimney Cap Damaged

The chimney cap was damaged.

- The furnace chimney cap was bent and damaged. It appears to have been resecured with wire.

Recommend repair or replacing the chimney cap.

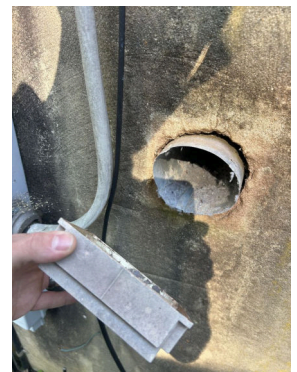
The vent for the dryer was not properly sealed or flashed. This can allow water to penetrate the siding and cause damage. Recommend a qualified siding contractor properly seal the dryer exhaust

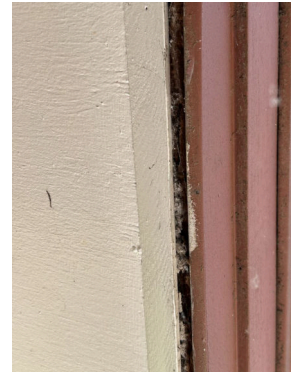
There are small gaps/openings in the exterior that can allow pests and moisture to enter the home. Recommend sealing these areas to prevent intrusion.

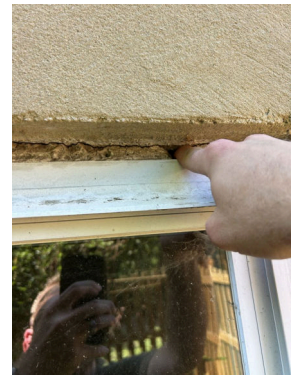
### 3.2.6 Improperly Flashes Window

A basement window appears to have been replaced and sealed with a foam. There does not appear to be any flashing in the area.

This can allow water to penetrate and cause damage.

Recommend a qualified contractor evaluate and repair as necessary.

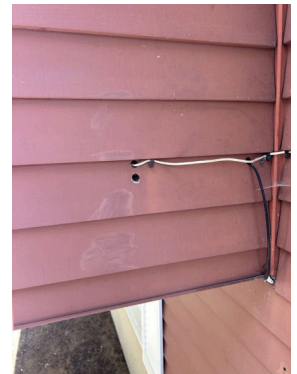
### 3.2.7 Unsealed penetrations in Siding

There were several unsealed penetrations in the brick where electrical or communication lines were run through. This can allow for water and pest intrusion into the building. Recommend repair by qualified mason.

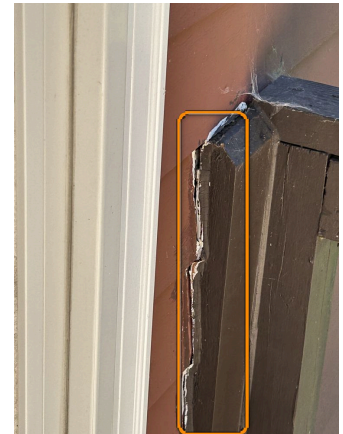
### 3.2.8 Deteriorating Caulk and Sealant

The caulk or Duct Seal Puddy used to seal penetrations and joints in the siding is deteriorating in one or more areas. This can allow water to penetrate the property. Recommend recaulking and sealing all open penetrations.

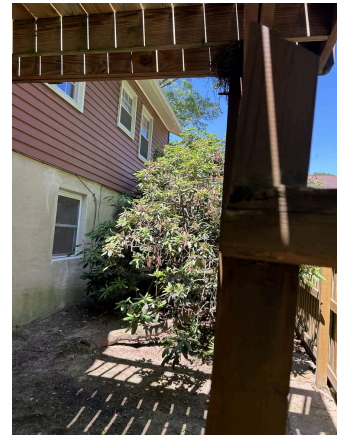
### 3.2.9 Vegetation on Siding

This can damage the building materials, stain it, and allow a pathway for moisture and pests into the home.

Recommend trimming back vegetation so that it is not in contact with the home, including in windy conditions.

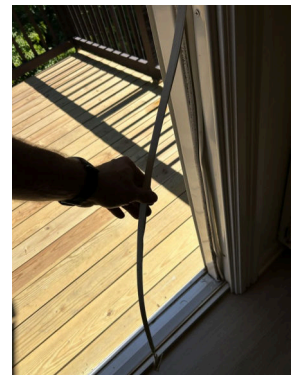
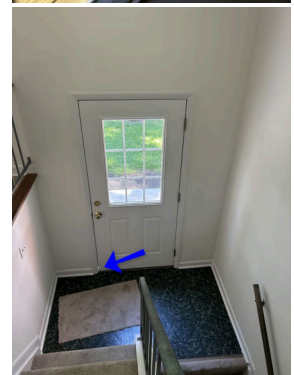
#### 3.3.2 Weatherstripping damaged/deteriorated

The weatherstripping on one or more exterior doors is damaged and may not be sealing properly. Recommend repairing or replacing the weatherstripping as necessary.

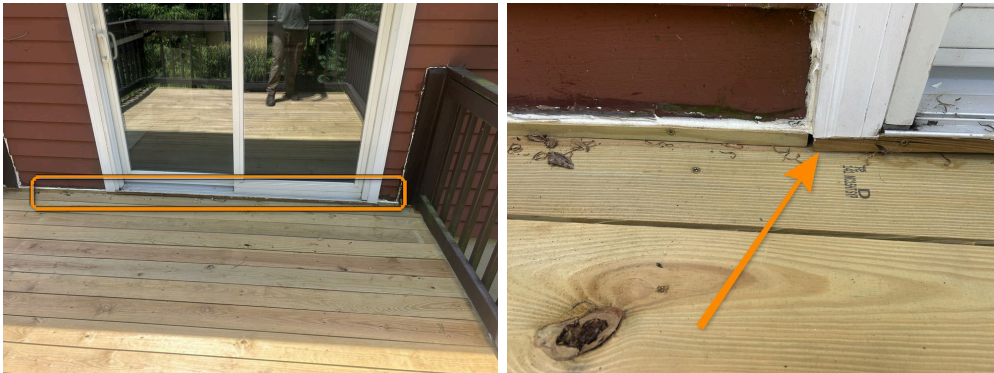
### 3.5.3 Ledger Board Improperly Flashed

One or more ledger boards installed on the house is either improperly flashed, or not flashed at all. This can allow water to penetrate behind the ledger, and cause damage. Recommend properly flashing the ledger board.

- It appears the rear deck boards were replaced with a different sized board (2x6 to 5/4x6) and the gap was filled with lumber and caulk, preventing the flashing from doing its job correctly.

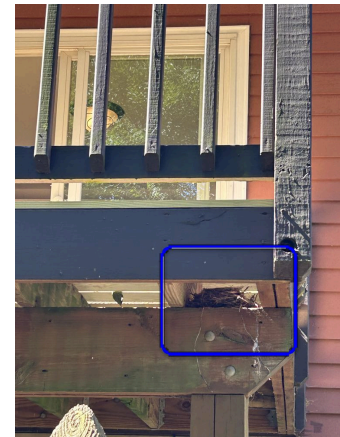
Bird nests were found below the deck or balcony. Birds nesting on or in a home can lead to the spread of disease and general dirtiness. Recommend removing the bird nests.

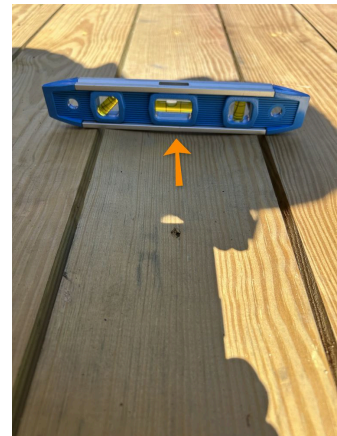
This can cause rainwater to sit on the board and cause damage.

Recommend removing and turning over the affected boards to promote proper drainage.

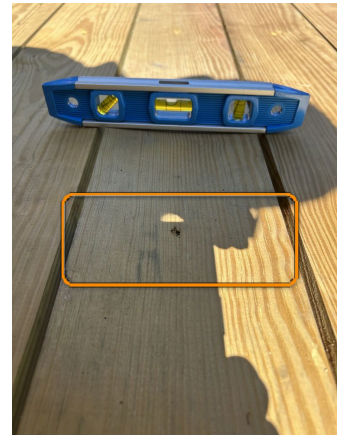
### 3.5.10 Deck Board Nailing Insufficient

One or more deck boards was secured to the joist with only one nail or screw. This can allow the board to rock side to side and become loose or damaged. Recommend ensuring all deck boards are properly secured to the joists.

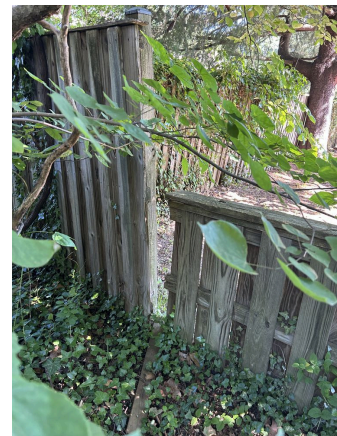
#### 3.6.1 Fence Damaged - Aesthetic

The fence was damaged in places. The client may wish to have it repaired for aesthetic reasons.

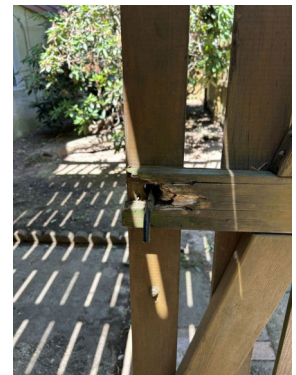
#### 3.6.2 Fence Gate Damaged

The fence gate is damaged and difficult to open, close and latch. Recommend evaluation and repair or replacement by a qualified professional

- Gate outside of basement door is damaged and dragging on the ground.

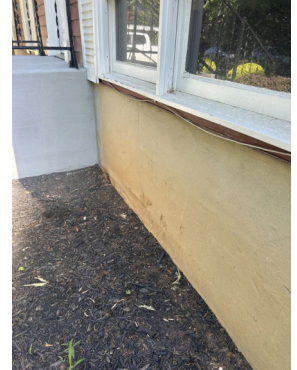
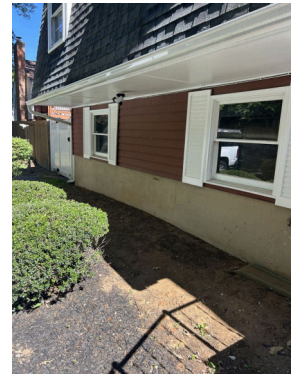
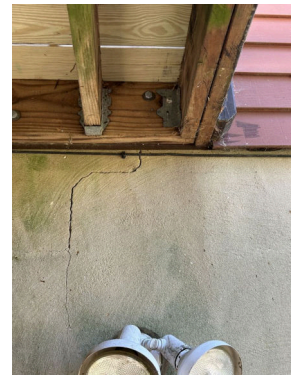
### 4.2.3 Minor Cracking in Parge Coat on Exterior Foundation Wall

Minor cracking was noted in one ore more areas of the parge coat on the exterior foundation walls.

A Parge coat is a thin layer of concrete placed over the foundation walls for cosmetic purposes. Cracks in the parge coat are normal and can occur over time due to age, deterioration, or settlement of the structure.

Recommend monitoring the area for any changes in the size or shape of the cracks.

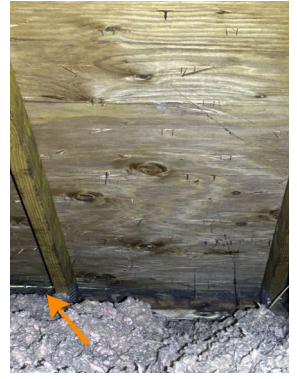
This could be caused by failing siding and flashing or failing eaves and can allow water pest and animal or bird intrusion. Recommend a qualified contractor evaluate and repair as necessary.

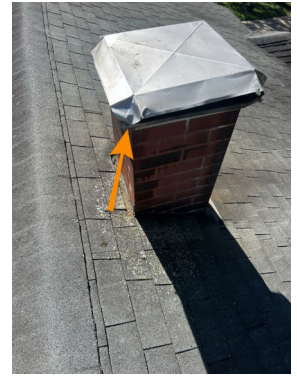
### 5.2.7 Leak from Exhaust Flue

Water staining was visible on the exhaust flue of the furnace.

This can be caused by a damaged or failing flue or chimney cap allowing water to enter the flue.

- The cap on the chimney for the furnace exhaust flue appears to have been damaged and repaired at one point. The leak may have already been corrected.

Recommend evaluation and repair by a qualified contractor.

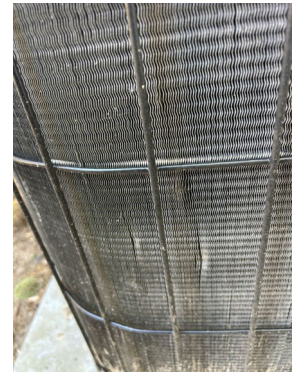
#### 6.1.6 Air Flow Restricted

Air flow to the air conditioner condenser was restricted. This may result in inefficient operation. Recommend cleaning dirt and/or debris from unit.

- The condenser coils were packed with dirt and multiple fins were bent

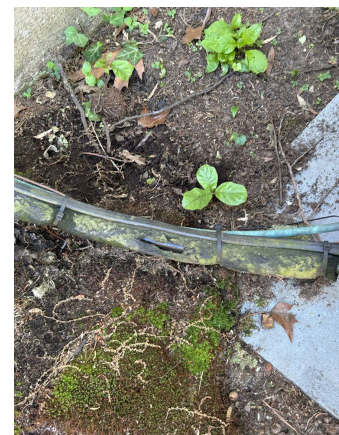
#### 6.1.7 Insulation Missing or Damaged

Missing or damaged insulation on refrigerant line can cause energy loss and condensation. Recommend replacing any missing/damaged insulation.

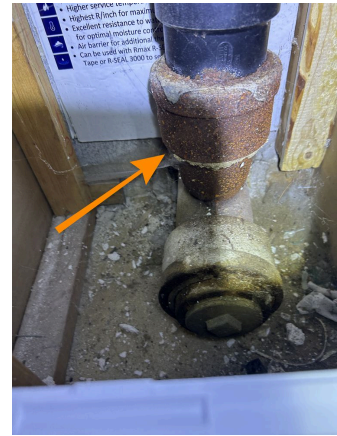
The drain system in the house contains components that are original to the home's construction. They are nearing the end of their expected useful life. Budget to replace these original components in the next 1-10 years.

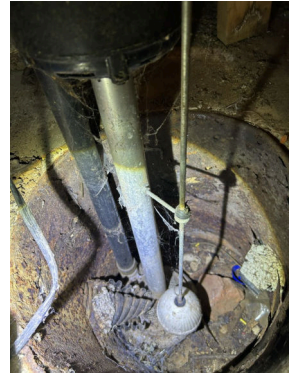
### 7.7.3 Sump Pump Crock Deteriorated

The crock containing the sump pump is deteriorated.

This will allow water channeled to the crock to leak out into the foundation.

Recommend replacing the sump pump crock.

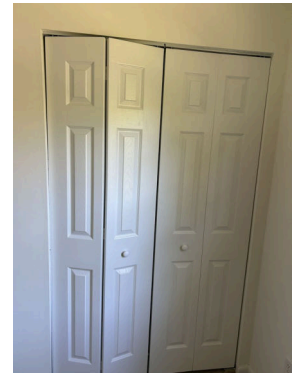
### 11.2.2 Bifold Door Doesnt Close

- Two springs were installed on the top bifold track - Only one is necessary. Recommend removing additional spring.

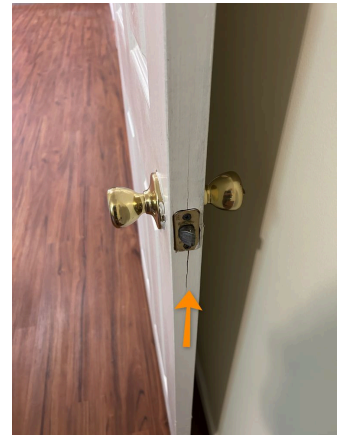
There is light damage to one or more interior doors from normal wear and tear. Damage consists of The client may wish to repair/replace the door for cosmetic reasons.

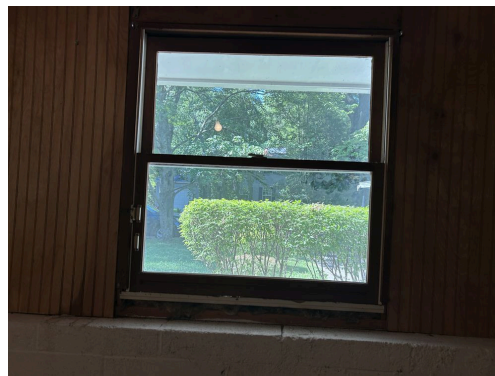
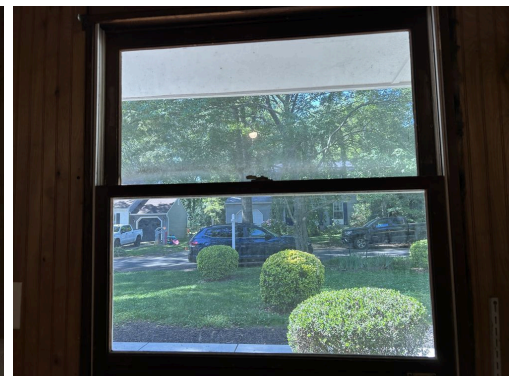
- Majority of windows and both sliding doors did not have screens installed. There were several window screens present in the basement, and no screens for the sliding doors.

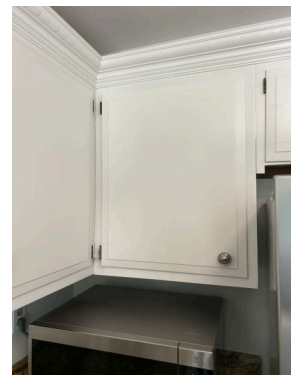
### 11.8.6 Cabinet Hinge Loose

One or more cabinet hinges were loose. Recommend a qualified handyman or cabinet contractor repair. Here is a helpful DIY article on cabinet repairs.
