UPDATED INTERNACHI RESIDENTIAL -2026-04-07

123 Sample Street, Demo City, ST 12345

6/04/2026 8:52AM

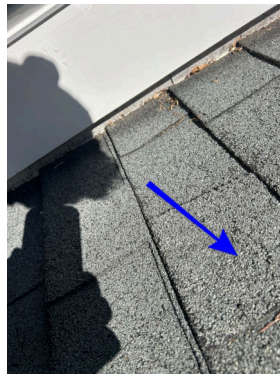
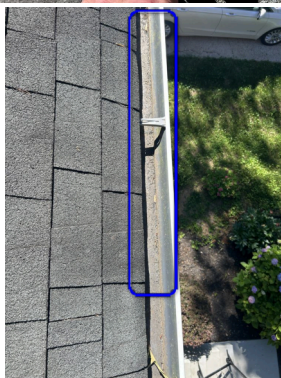
Slight granule loss was noted on the roof covering, and visible in the gutters of the property. Granule loss that is uniform across the roof is usually a result of normal weathering. Over time, the bond between the granules and asphalt deteriorates, and granules will be loosened and carried away by runoff. Newly installed roofs can also shed a large amount of granules called "hitchhikers." These are granules that were on top of the shingles during manufacturing, but were not completely embedded, and wash away easily during precipitation. Recommend monitoring the area for any signs of further granule loss or erosion of the shingles.

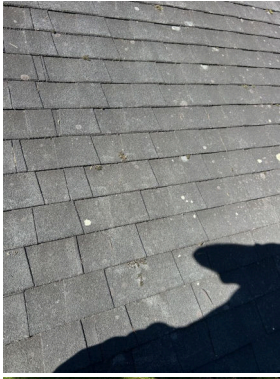
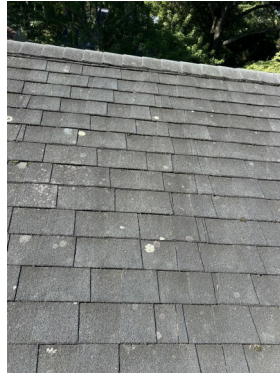
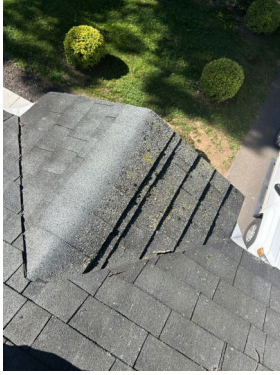
### 2.2.5 Moss growing on shingles

There is moss growing in one or more areas of the roof. Moss grows on a roof when there is adequate moisture and debris to promote growth. Because moss growing on a roof surface will hold moisture on the roof longer than other areas, these growths can reduce the life of the roof covering. Recommend cleaning moss off the roof - We recommend NOT using a power washer to clean the roof as it can damage the shingles.

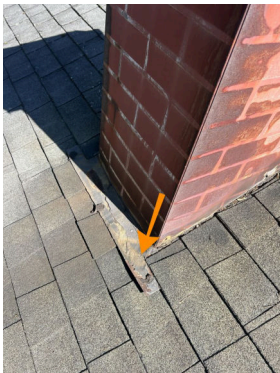
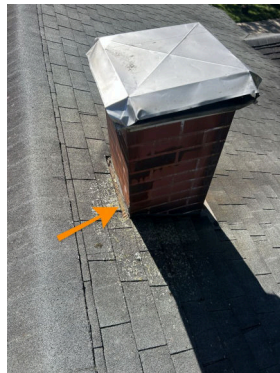
#### 2.4.2 Corroded - Minor

Roof flashing showed signs of corrosion, but are still in working condition. Flashing should be monitored to prevent severe corrosion leading to moisture intrusion.

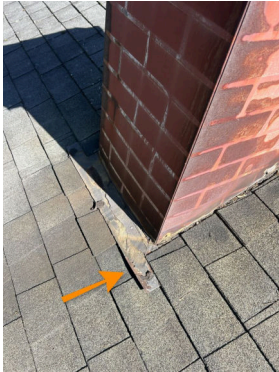
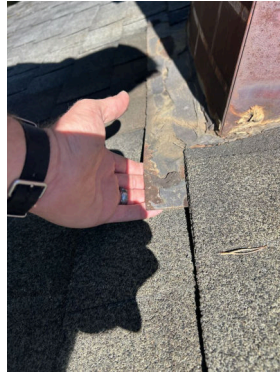
### 2.4.3 Loose/Separated

Flashings observed to be loose or separated, which can lead to water intrusion and/or mold. Recommend a qualified roofing contractor repair.

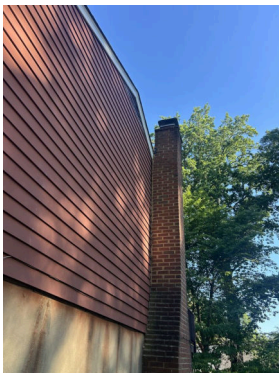
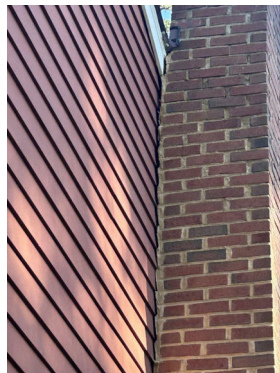
**Location:** Exterior East

Not only can this allow water to penetrate the area and potentially cause damage, but it may indicate that the chimney has shifted and is not properly secured to the structure.

Recommend a qualified contractor evaluate the chimney to ensure it is properly secured to the structure and sealing the area to ensure no water penetration.

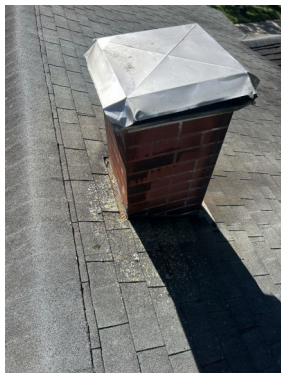
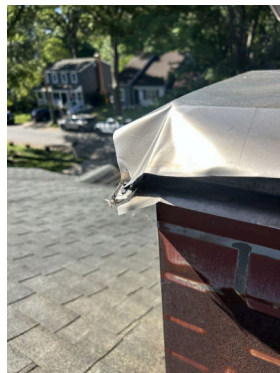
### 2.5.4 Chimney Cap Damaged

The chimney cap was damaged.

- The furnace chimney cap was bent and damaged. It appears to have been resecured with wire.

Recommend repair or replacing the chimney cap.

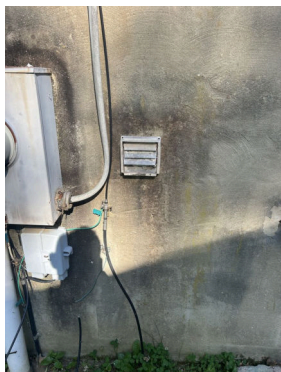
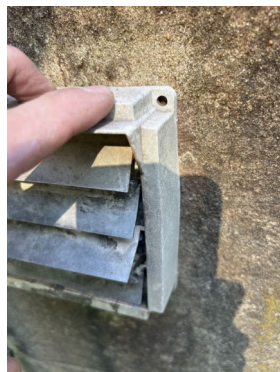
**Location:** Exterior East

The vent for the dryer was not properly sealed or flashed. This can allow water to penetrate the siding and cause damage. Recommend a qualified siding contractor properly seal the dryer exhaust

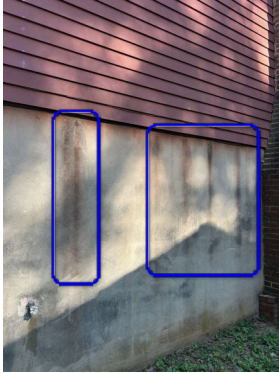
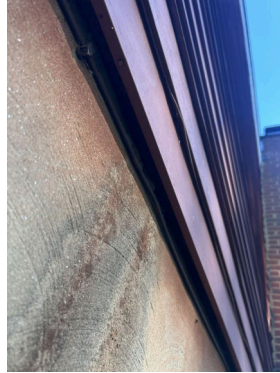
### 3.2.4 Staining Below Siding

Staining was visible on the foundation walls below the siding in one or more areas.

This type of siding may indicate water had penetrated the siding and came out below.

Recommend monitoring the areas to ensure no rot or water intrusion.

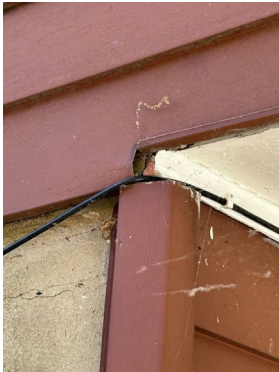
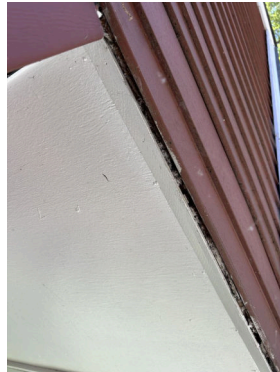
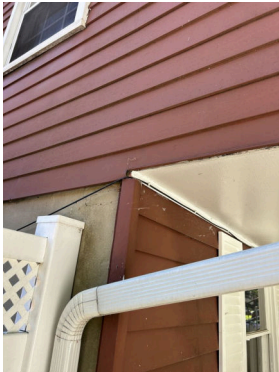
### 3.2.5 Gaps in Siding

There are small gaps/openings in the exterior that can allow pests and moisture to enter the home. Recommend sealing these areas to prevent intrusion.

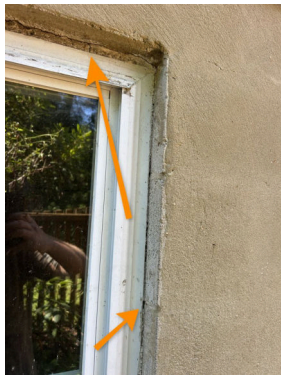
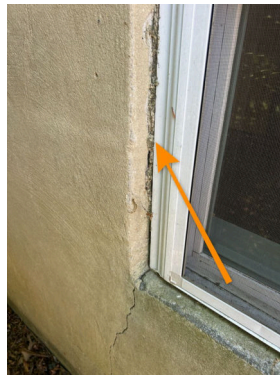
### 3.2.6 Improperly Flashes Window

A basement window appears to have been replaced and sealed with a foam. There does not appear to be any flashing in the area.

This can allow water to penetrate and cause damage.

Recommend a qualified contractor evaluate and repair as necessary.

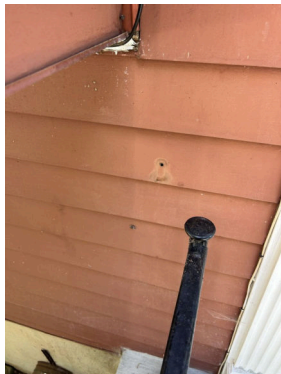
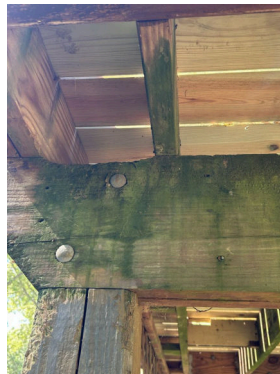
### 3.2.7 Unsealed penetrations in Siding

There were several unsealed penetrations in the brick where electrical or communication lines were run through. This can allow for water and pest intrusion into the building. Recommend repair by qualified mason.

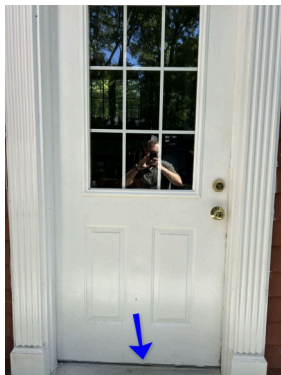
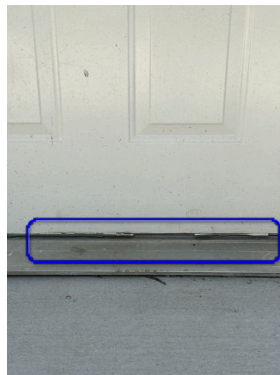
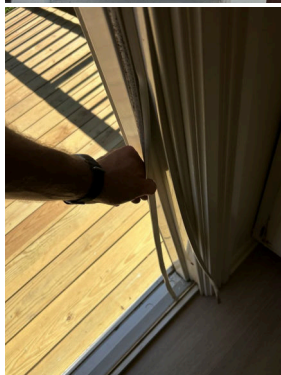
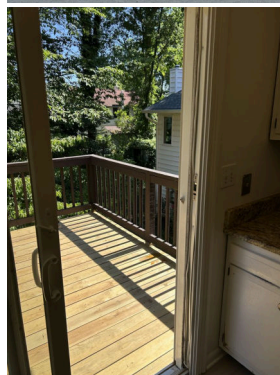
#### 3.3.2 Weatherstripping damaged/deteriorated

The weatherstripping on one or more exterior doors is damaged and may not be sealing properly. Recommend repairing or replacing the weatherstripping as necessary.

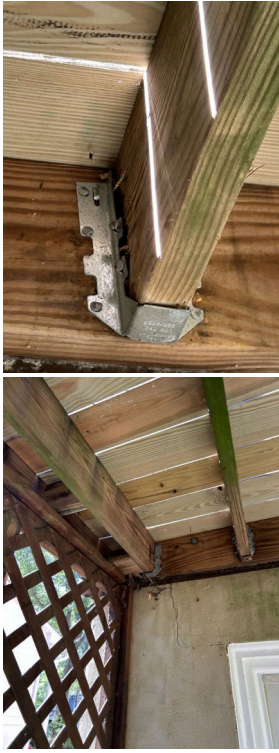
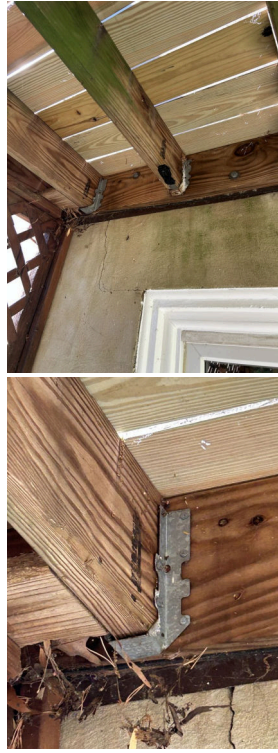
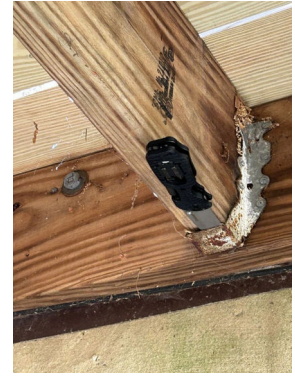
**Location:** Deck

Joist hangers on the deck were improperly installed.

Improperly secured hangers will provide less support than they are designed to hold.

- There are gaps at the bottom and sides of one or more hangers

Recommend a qualified contractor evaluate and repair or replace the hangers as necessary.

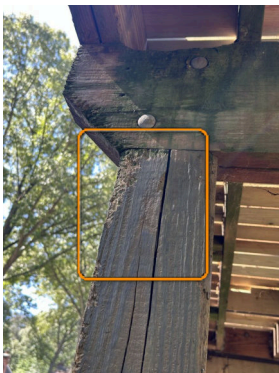
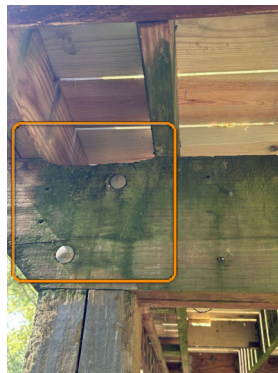
### 3.5.6 Deteriorated Wooden Components

Wooden components of the deck showing signs of deterioration and rot.

This can indicate that the component may fail Recommend evaluating and repairing or replacing the components.

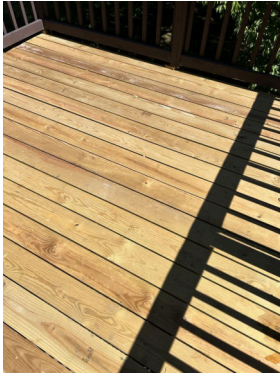
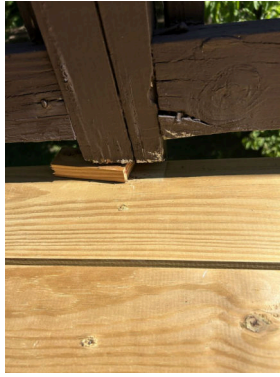
### 3.5.8 Replacement Deck Boards Undersized

The deck boards have been replaced. It appears that the original deck boards were 2x6" and they were replaced with 5/4x6 boards.

These gaps may weaken the structure supporting the railings.

Recommend evaluation and repair by a qualified contractor.

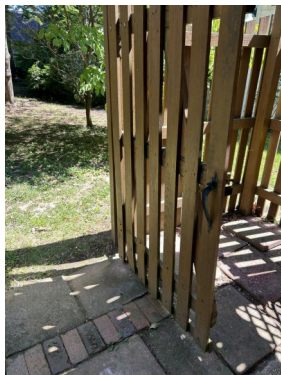
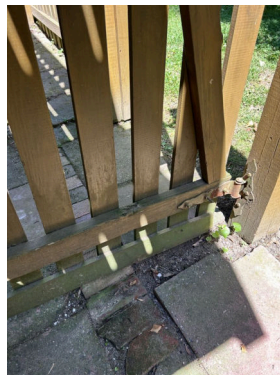
#### 3.6.2 Fence Gate Damaged

The fence gate is damaged and difficult to open, close and latch. Recommend evaluation and repair or replacement by a qualified professional

- Gate outside of basement door is damaged and dragging on the ground.

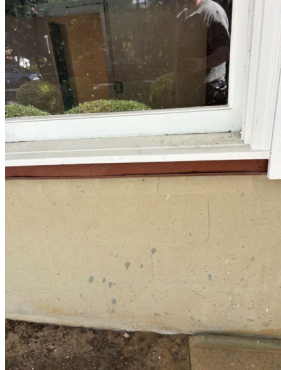
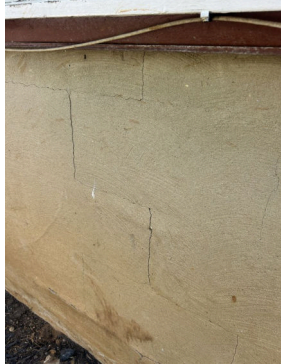
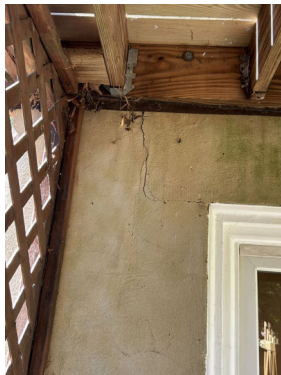
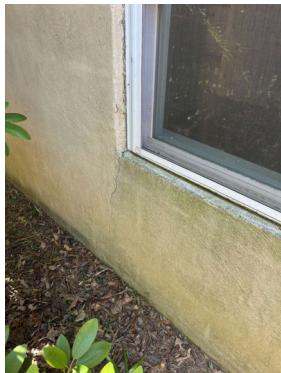
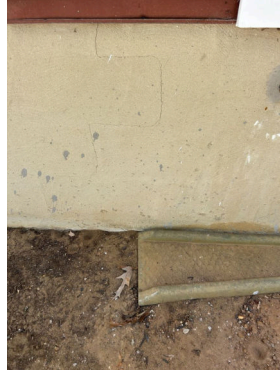
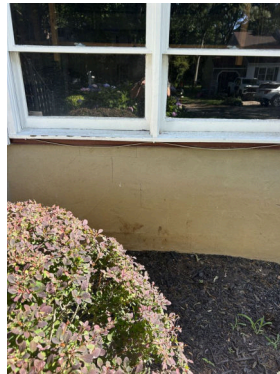
### 4.2.3 Minor Cracking in Parge Coat on Exterior Foundation Wall

Minor cracking was noted in one ore more areas of the parge coat on the exterior foundation walls.

A Parge coat is a thin layer of concrete placed over the foundation walls for cosmetic purposes. Cracks in the parge coat are normal and can occur over time due to age, deterioration, or settlement of the structure.

Recommend monitoring the area for any changes in the size or shape of the cracks.

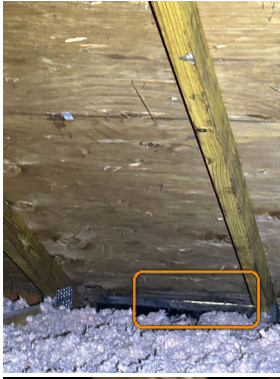
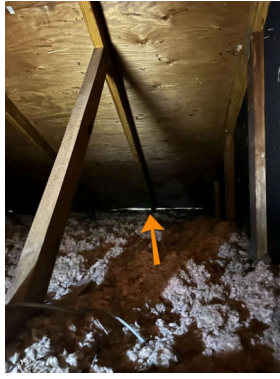
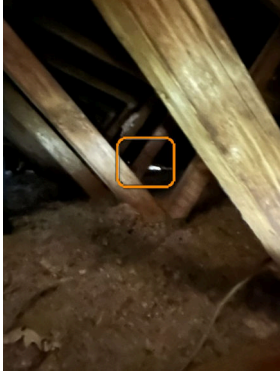
This could be caused by failing siding and flashing or failing eaves and can allow water pest and animal or bird intrusion. Recommend a qualified contractor evaluate and repair as necessary.

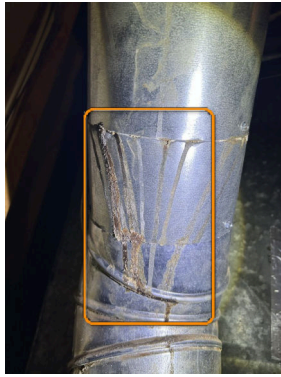
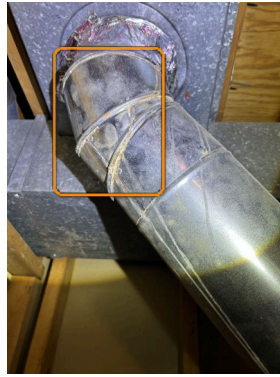
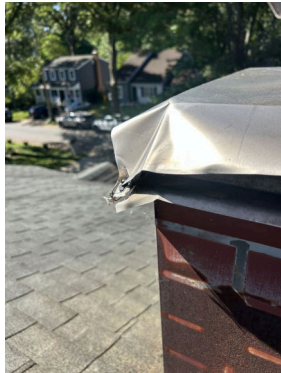
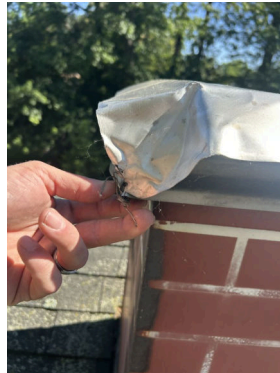
### 5.2.7 Leak from Exhaust Flue

Water staining was visible on the exhaust flue of the furnace.

This can be caused by a damaged or failing flue or chimney cap allowing water to enter the flue.

- The cap on the chimney for the furnace exhaust flue appears to have been damaged and repaired at one point. The leak may have already been corrected.

Recommend evaluation and repair by a qualified contractor.

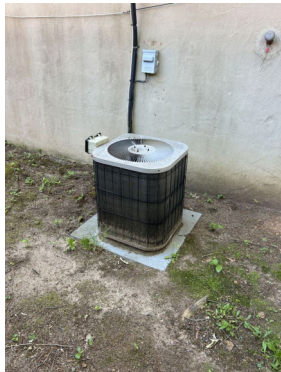
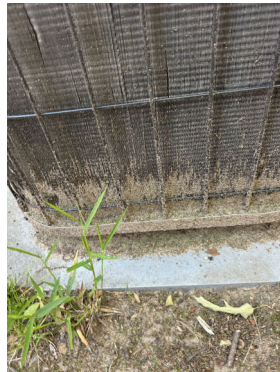
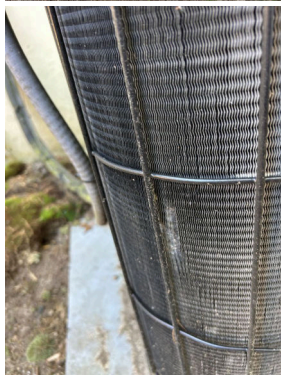
#### 6.1.6 Air Flow Restricted

Air flow to the air conditioner condenser was restricted. This may result in inefficient operation. Recommend cleaning dirt and/or debris from unit.

- The condenser coils were packed with dirt and multiple fins were bent

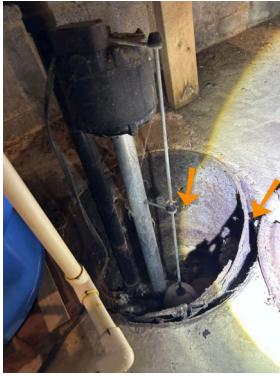
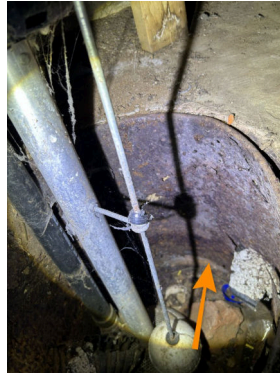
### 7.7.3 Sump Pump Crock Deteriorated

The crock containing the sump pump is deteriorated.

This will allow water channeled to the crock to leak out into the foundation.

Recommend replacing the sump pump crock.

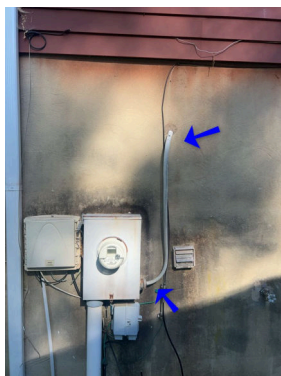
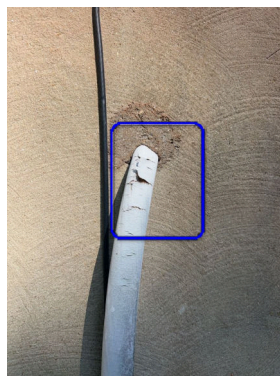
#### 8.1.2 Frayed Sheathing

Sheathing on the service entrance cable is damaged or frayed. Recommend contacting a qualified electrician to evaluate and repair.

**Location:** Exterior East

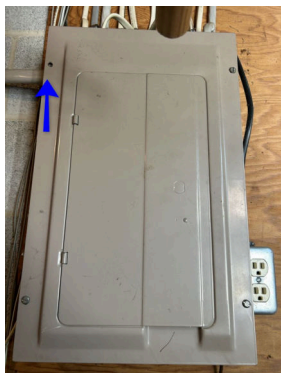
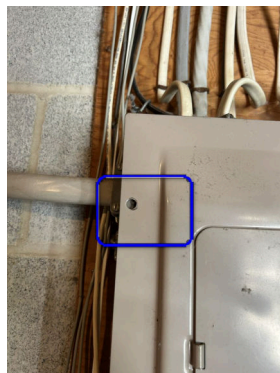
### 8.2.10 Missing Dead Front Cover Screws

One or more screws securing the dead front cover to the electrical service panel are missing. Recommend replacing the missing screws with the blunt tipped panel screws.

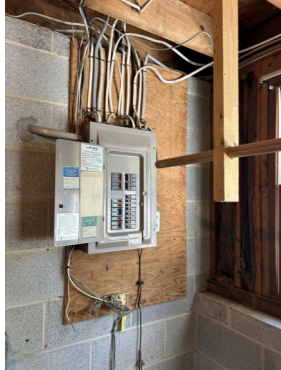
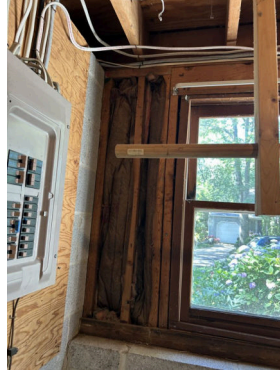
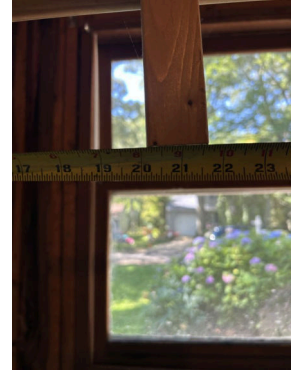
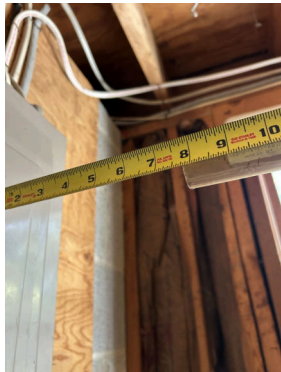
## 8.2.11 Insufficient Working Space at Panel

The proper amount of working space is approximately the size of a fridge.

Recommend removing the drying rack installed in front of the panel.

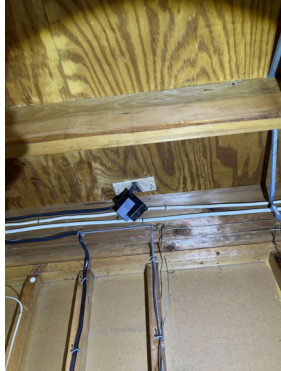
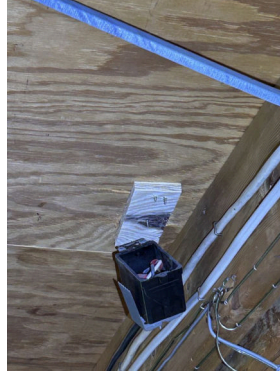
### 8.3.4 Junction Box Cover Missing

One or more electrical junction boxes s missing its cover.

This poses a shock or electrocution hazard.

**Location:** Basement Laundry Room Ceiling

Recommend installing a cover over all open junction boxes

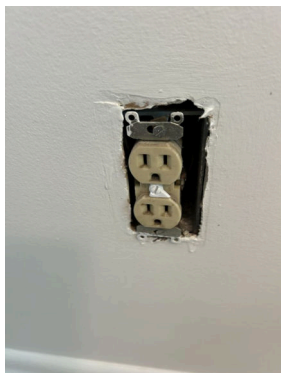
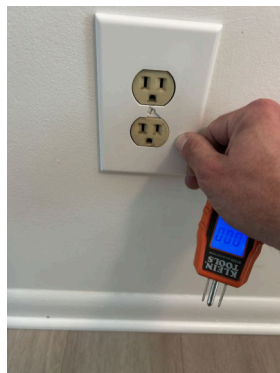
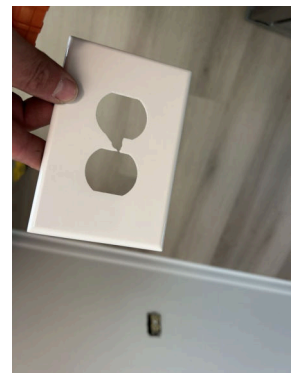
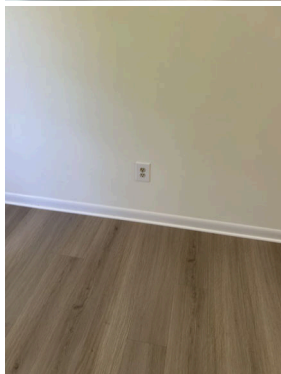
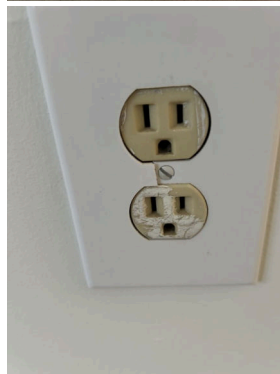
#### 8.4.1 Cover Plates Damaged

One or more receptacles have a damaged cover plate.

Recommend replacement.

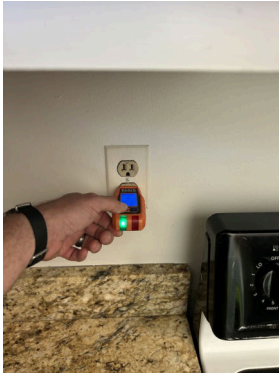
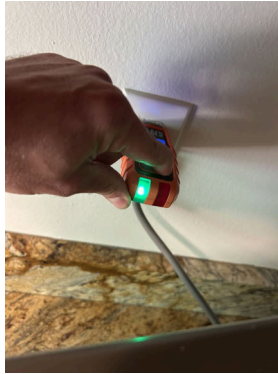
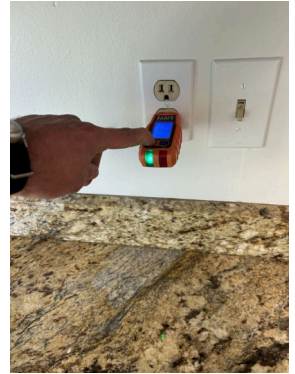
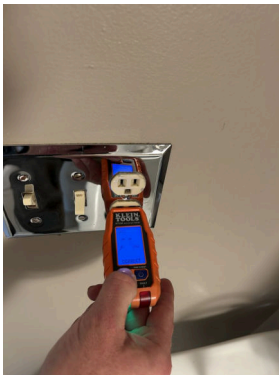
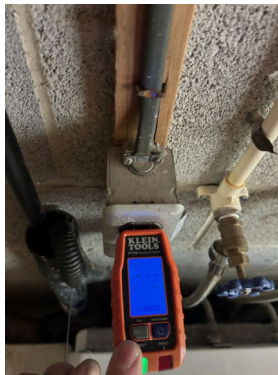
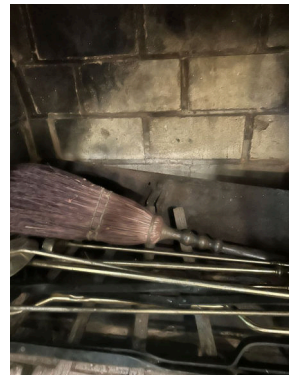
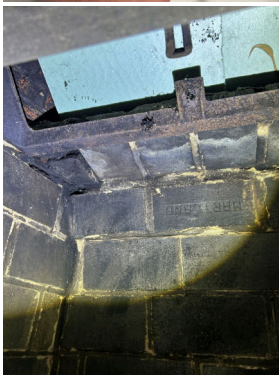
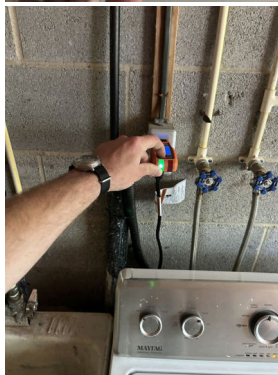
### 8.5.1 GFCI Missing

GFCI protection was missing from one or more required areas.

Recommend a qualified electrician evaluate and ensure receptacles are GFCI protected.

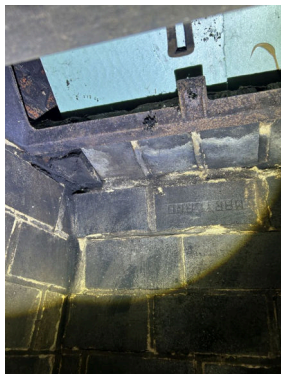
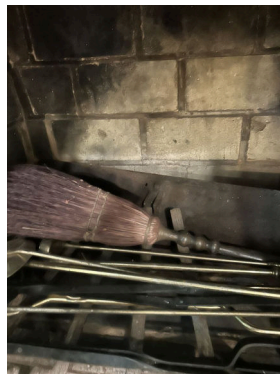
#### 9.2.1 Damper Missing

The flue damper is missing in the chimney.

Without the flue damper, warm air will be pushed up the chimney and cause higher heating bills. It can also allow for rodent entry and water intrusion.

- It appears the damper was removed and was placed inside the firebox

Recommend a qualified chimney technician replace the missing flue damper.

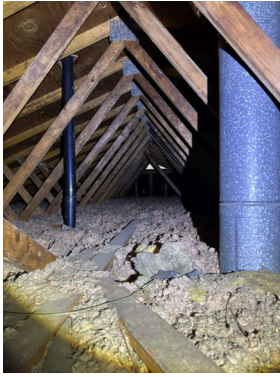
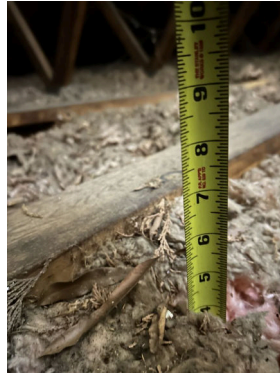
10.2.3 **Insufficient Insulation**

Modern insulation standards require an R-Value of 49 in an attic space, which is greater than the insulation R-value currently installed in the property. Client may wish to install additional insulation in the attic space.

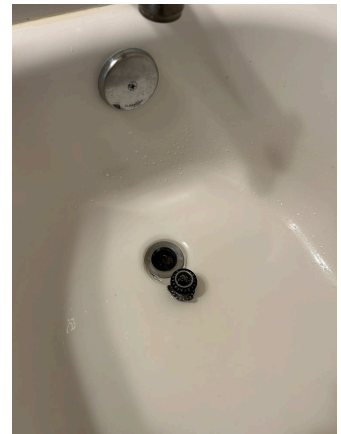
#### 11.1.1 Tub Stopper Missing

There was no stopper present, or the stopper did not function, and we were unable to properly evaluate the tub.

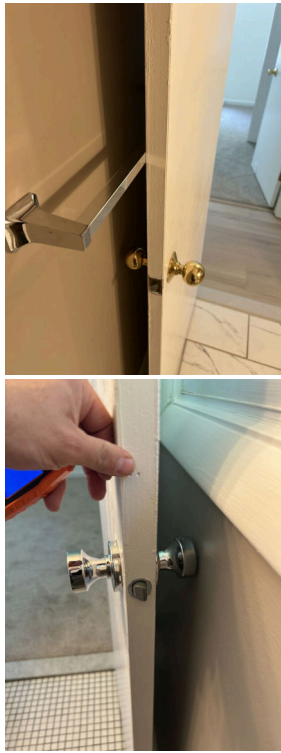
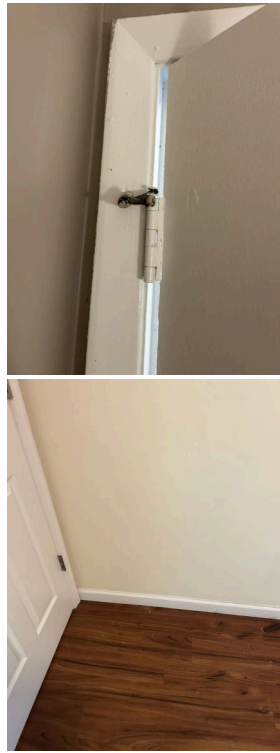
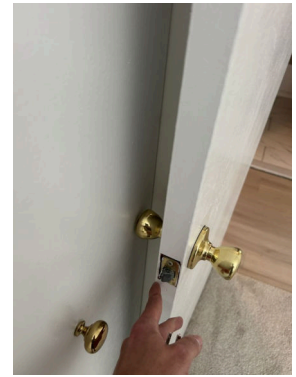
#### 11.2.1 Doorstops Damaged or Missing

One or more doorstops were damaged or missing. These should be repaired/replaced to prevent damage to doors and walls.

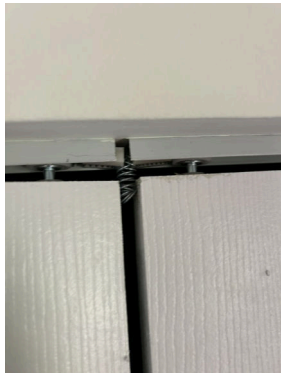
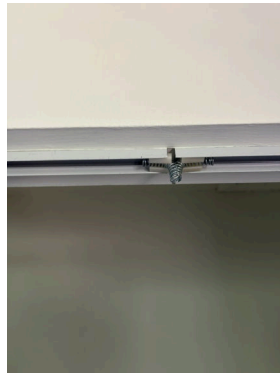
### 11.2.2 Bifold Door Doesnt Close

- Two springs were installed on the top bifold track - Only one is necessary. Recommend removing additional spring.

Recommend evaluation and repair by a qualified handyman

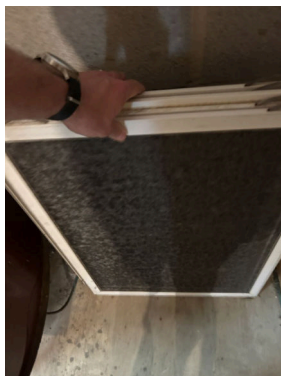
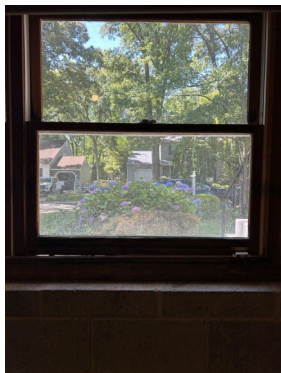
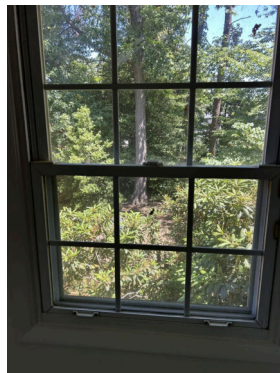
11.3.3 **Missing Screen**

One or more windows were missing a screen. Recommend replacement.

- Majority of windows and both sliding doors did not have screens installed. There were several window screens present in the basement, and no screens for the sliding doors.

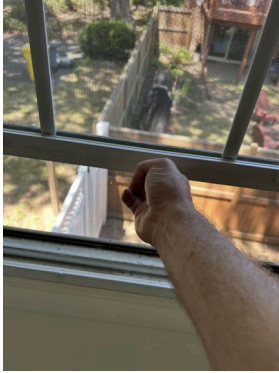
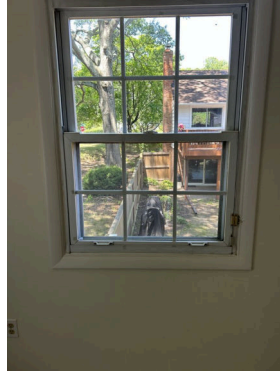
### 11.3.4 Failing Window Tensioner

The window tensioner in one or more windows is failing, causing the window not to open/close properly.

Recommend repair or replacement of tensioner.

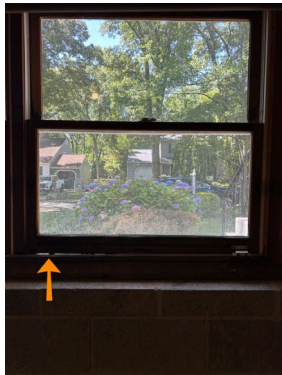
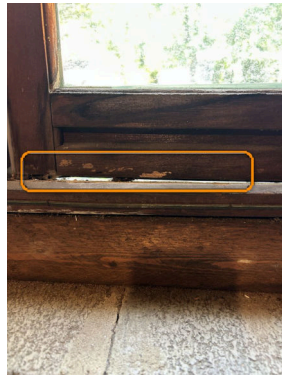
**Location:** Basement Windows

### 11.3.6 Weatherstripping damaged

The weatherstripping on one or more windows was damaged or missing. This can reduce the home's energy efficiency. Recommend a qualified person repair.

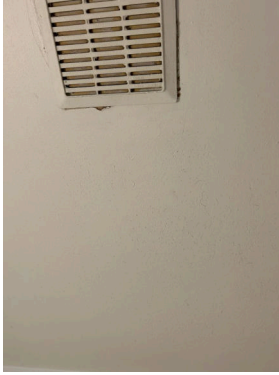
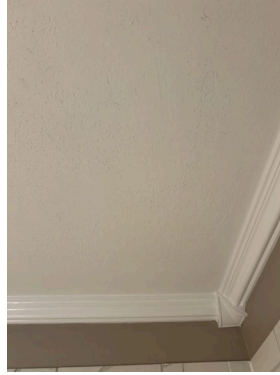
**Location:** Hallway Bathroom

11.6.2 **Minor Damage**

Minor damage or deterioration to the ceiling was visible at the time of the inspection.

- Drywall and paint on the ceiling of the bathroom was chipping or damaged. This can occur when moisture stays in the bathroom while showering. Recommend ensuring the bathroom vent is in use while showering and operating correctly.

Recommend monitoring the area for future damage.

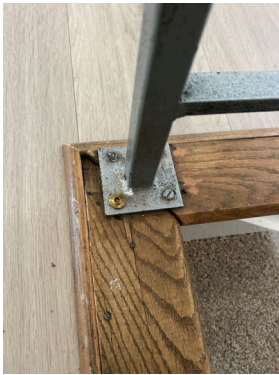
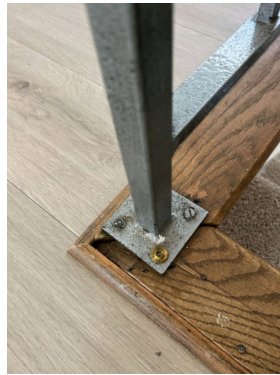
#### 11.7.1 Damaged Support

One or more supports for the railing was damaged at the time of inspection

- The trim supporting the railing around the top of the stairs was damaged. It appears a longer screw was installed to properly secure the railing. The railing is secure, client should monitor for it becoming loose again, and possible repair or replacement.

Recommend repair or replacement by a qualified contractor.

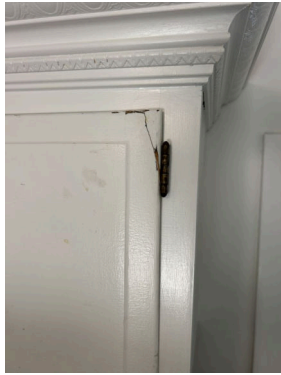
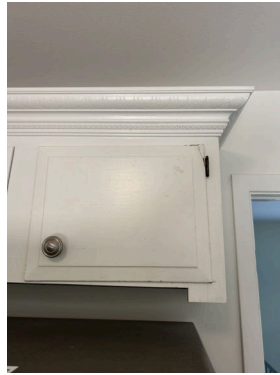
**Location:** Kitchen

#### 11.8.3 Cabinets Damaged

Cabinets had visible damage at time of inspection.

- Inspector did not open the cabinet doors to prevent further damage.

Recommend a qualified cabinets contractor evaluate and repair.

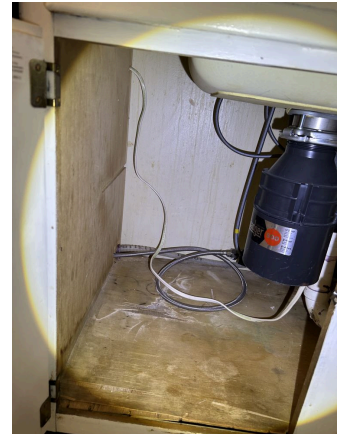
**Location:** Kitchen

### 11.8.5 Previous water Damage Below Kitchen Sink

The floor of the cabinet below the kitchen sink showed signs of a previous leak.

Recommend monitoring the area for any future leaks or damage.

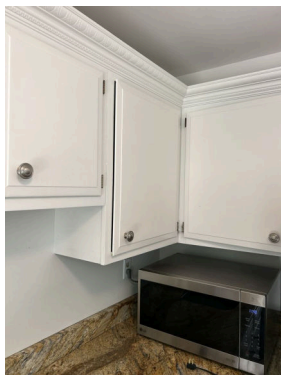
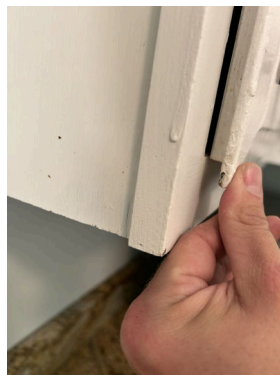
**Location:** Kitchen

### 11.8.6 Cabinet Hinge Loose

One or more cabinet hinges were loose. Recommend a qualified handyman or cabinet contractor repair. Here is a helpful DIY article on cabinet repairs.

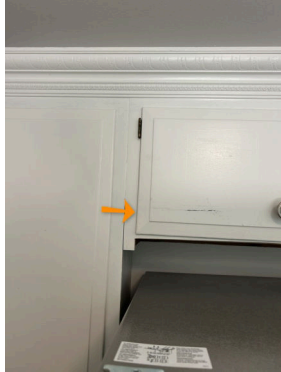
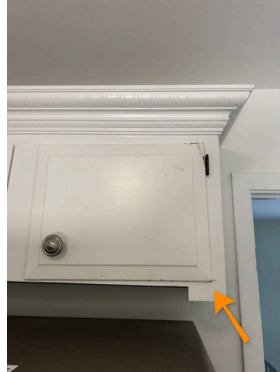
**Location:** Kitchen

### 11.8.7 Cabinet Hinge Missing

One or more cabinet doors was missing a hinge.

This can cause the door to fall out of alignment and not operate properly. Recommend replacing the missing hinge.

- Inspector did not open the cabinet doors to prevent further damage.

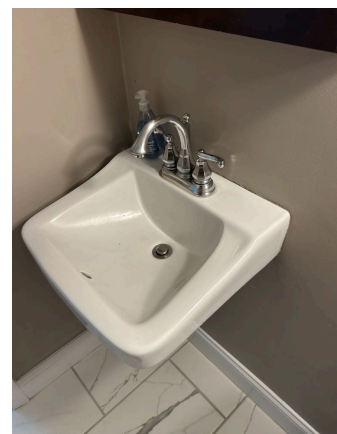
**Location:** Hallway Bathroom

#### 11.9.2 Vanity Loose

The wall mounted vanity was loose on its bracket.

Recommend qualified contractor secure vanity properly.

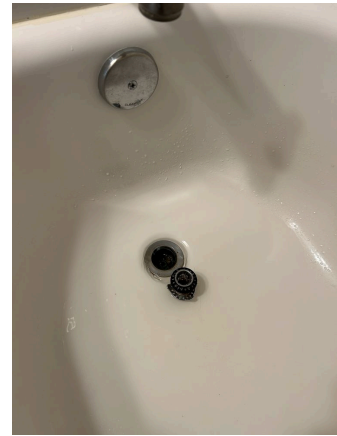
**Location:** Hallway Bathroom

### 11.9.3 Tub stopper Damaged or missing

One or more tub stoppers was damaged or did not operate correctly.

Recommend repair or replacement

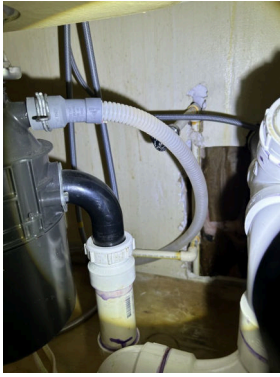
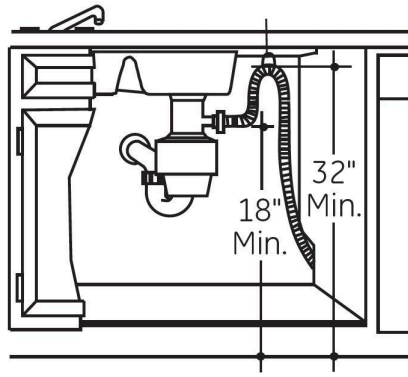
**Location:** Kitchen

##### 12.1.2 No Dishwasher High Loop

The dishwasher drain hose lacks a required high loop (or air gap) and runs downward directly into the garbage disposal or sink drain. Without the high loop, dirty sink water can siphon back into the dishwasher during drainage cycles, contaminating clean dishes, creating foul odors, promoting mold growth, and potentially causing premature failure of the dishwasher pump. Recommend re-routing the dishwasher drain line to ensure it has a high loop.

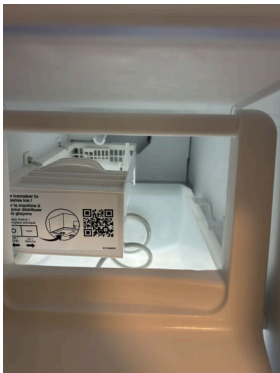
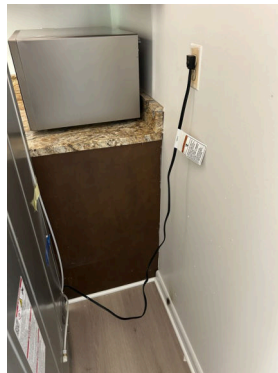
#### 12.2.2 No water line installed

A refrigerator with an ice maker and water dispenser was installed in the property, but there is no water line present to supply the refrigerator. Recommend a qualified plumber install a water line if the desired.

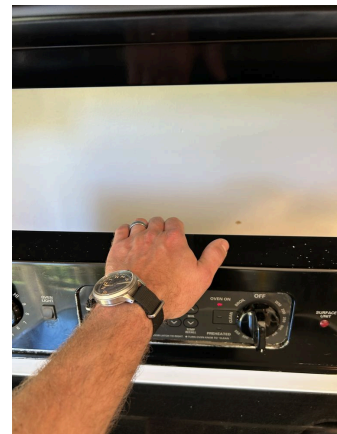
#### 12.3.4 Missing Anti-Tip Bracket

Recommend installing an anti-tip bracket.
